# Manhole Inspection Summary

Manhole # S21A\_\_041MH

**Location** Address: **601 MONROE ST**

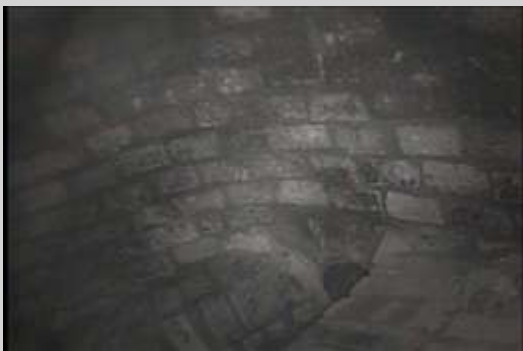
3 O'Clock Inflow

8 in. Circular Gravity Sewer  
Pipe In @ 3 O'Clock

Pipe Height: **7.2** (in.) Rod and Bar (Angled)  
Pipe Material: **Clay** ☐ Pipe Lined  
Invert Depth: **7.33** (ft.) Flow Characteristics: **None**  
Deposits: ☒ None ☐ Mud ☐ Sludge ☐ Debris ☐ Grease  
Silt Depth: (in.) Deposits Extent:  
Infiltration: **None** Pipe Seal Cond: **Sound**

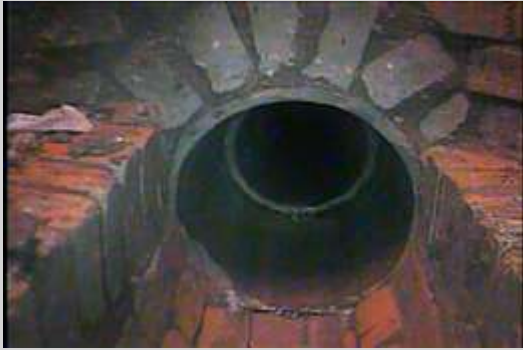
6 O'Clock Inflow

10 in. Circular Gravity Sewer  
Pipe In @ 6 O'Clock

Pipe Height: **9.6** (in.) Rod and Bar (Angled)

Infiltration: **None** Pipe Seal Cond: **Sound**
